**CONSENT ORDER
ISSUED UNDER THE
WATER POLLUTION CONTROL ACT
WEST VIRGINIA CODE, CHAPTER 22, ARTICLE 11**

TO: Mountain Valley Pipeline, LLC
Attn: Robert J. Cooper
Senior Vice President, Engineering and Construction
625 Liberty Ave, Ste 1700
Pittsburgh, PA 15222

DATE: April 19, 2019

ORDER NO.: 8951

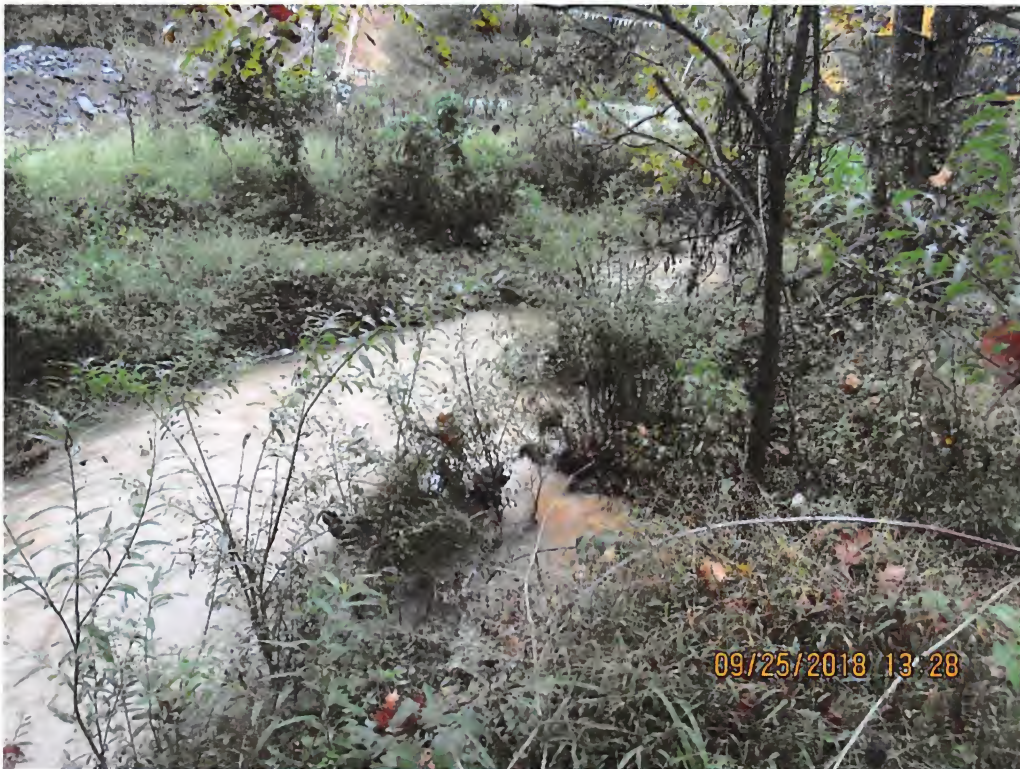
Photo 5: Sediment laden water entering UNT of Knawls Creek near station 3634+00 from failed perimeter controls.

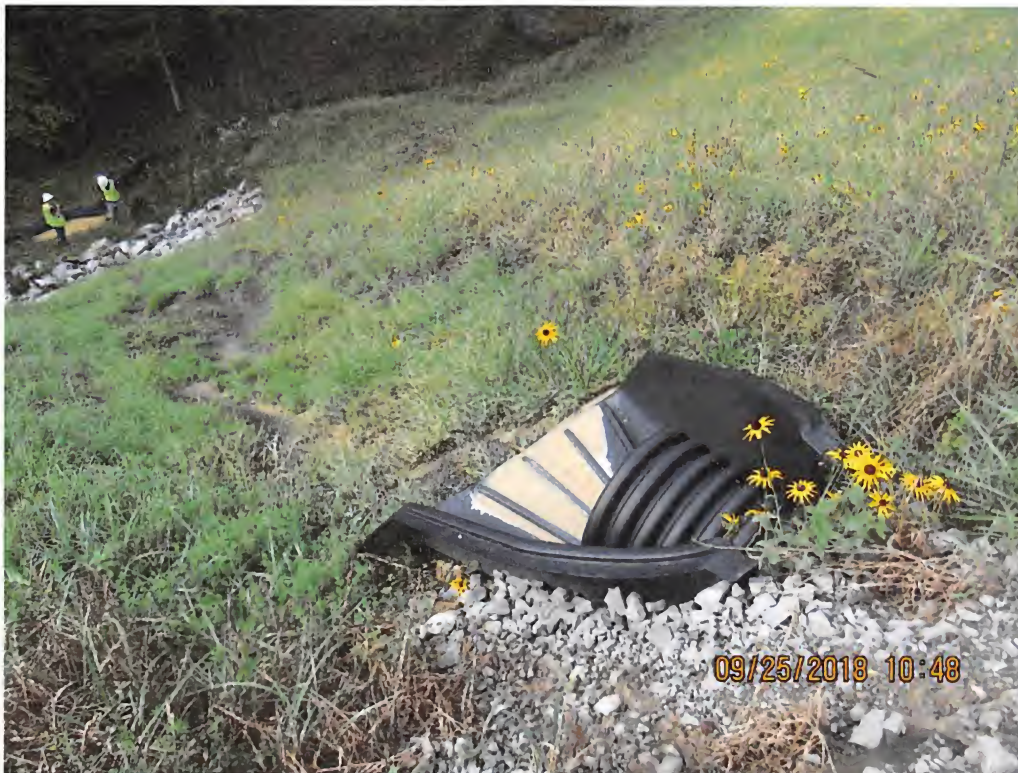
Photo 6: Convergence of UNT of Knawls Creek with sediment laden water mixing with Knawls Creek.

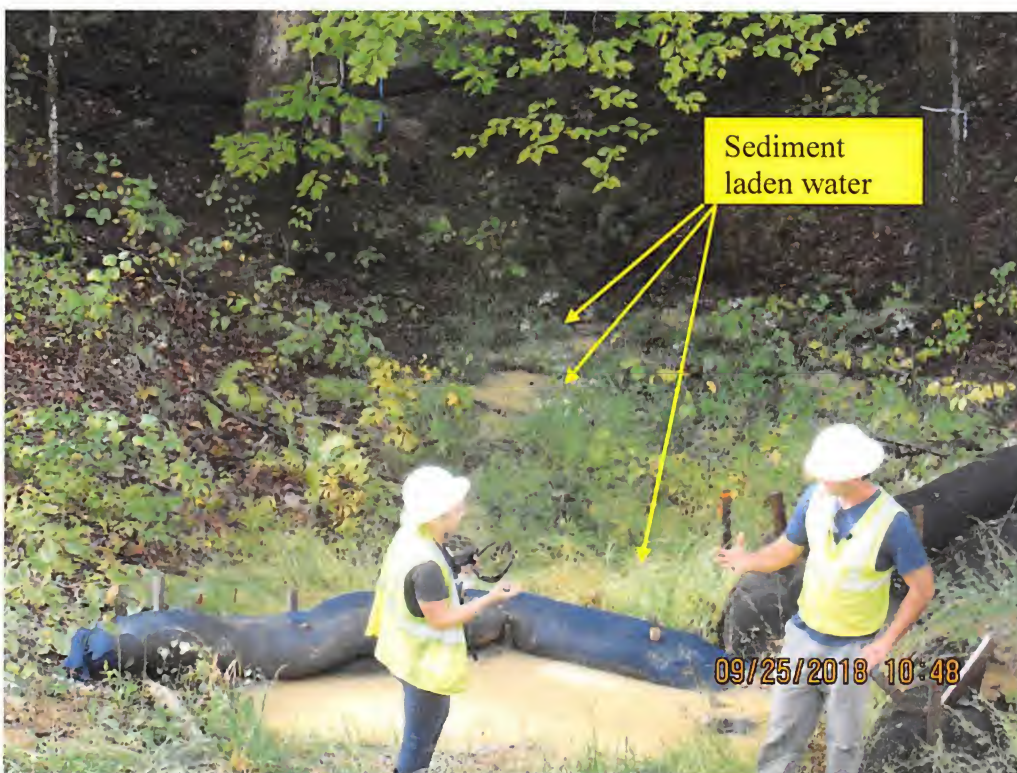
Photo 1: Station 550 outlet and sump at base of fill slope where perimeter controls failed allowing sediment laden water to leave site and create conditions not allowable in UNT of Little Kanawha.

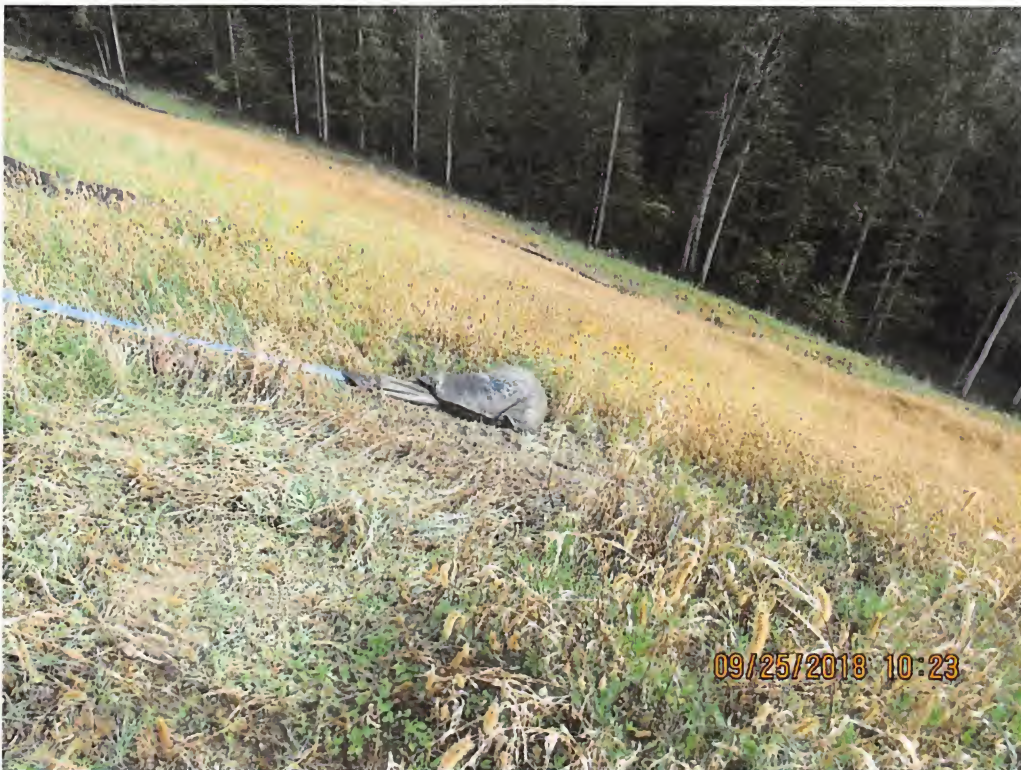
Photo 3: Conditions not allowable in UNT of Little Kanawha River down gradient of photo 2.

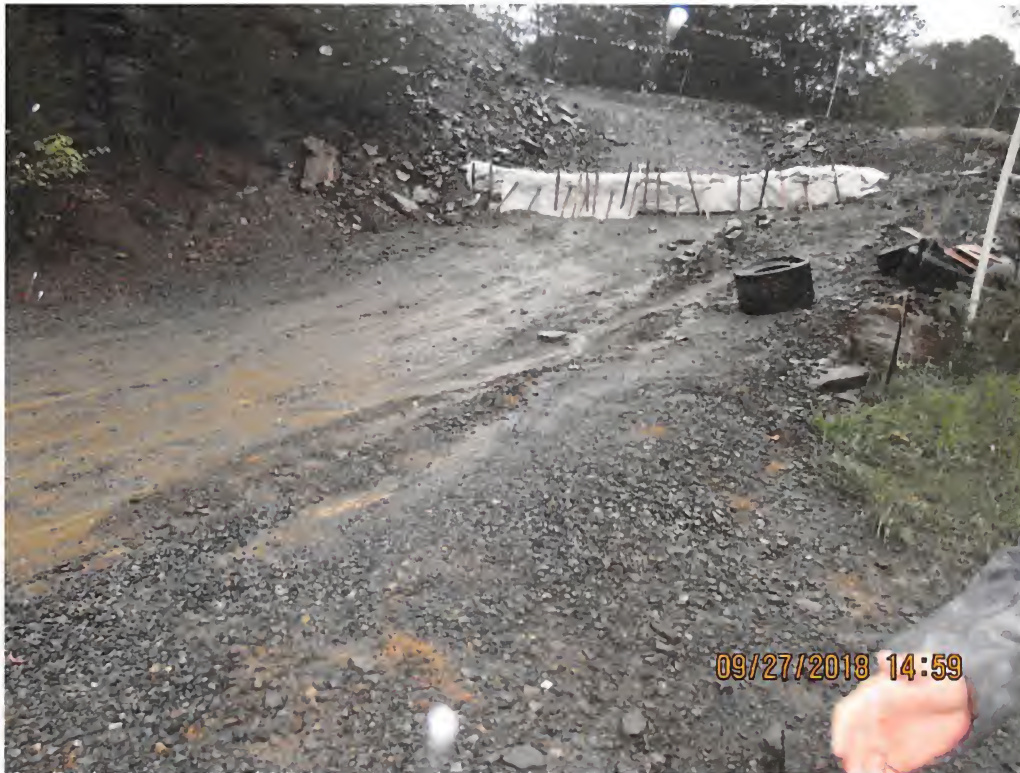
Photo 5: 2 of 3 improperly installed filter fabric bags still in use on north eastern side of site.

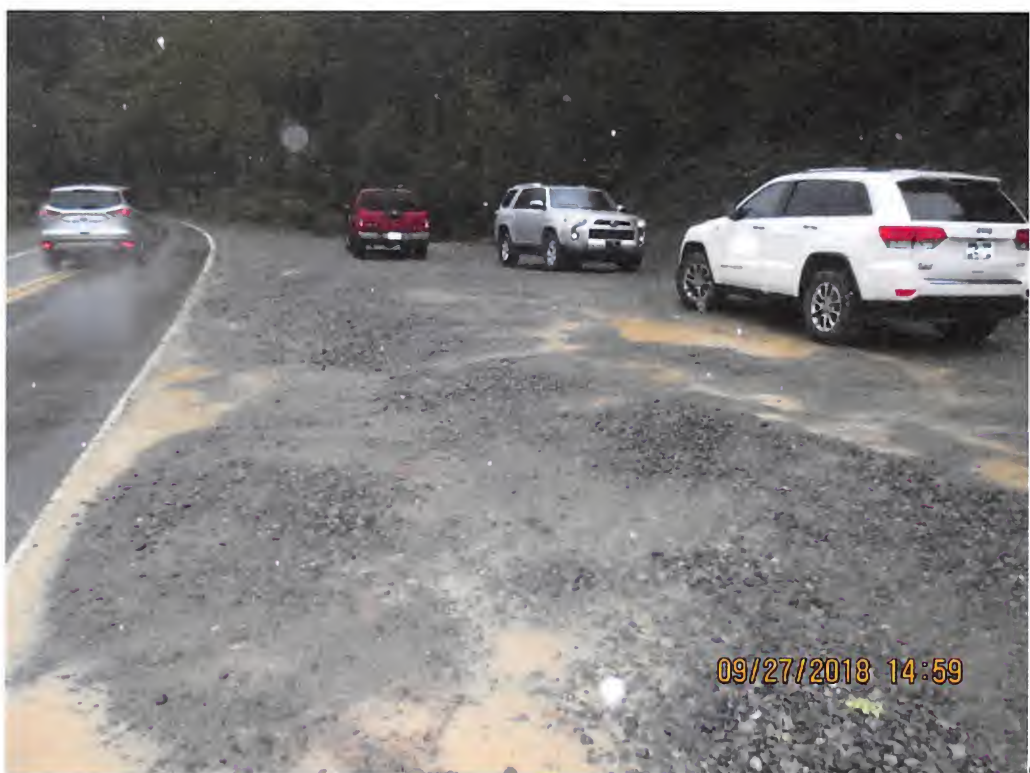
Area where sediment laden water was leaving site and being intercepted by road side ditch along Route 122.

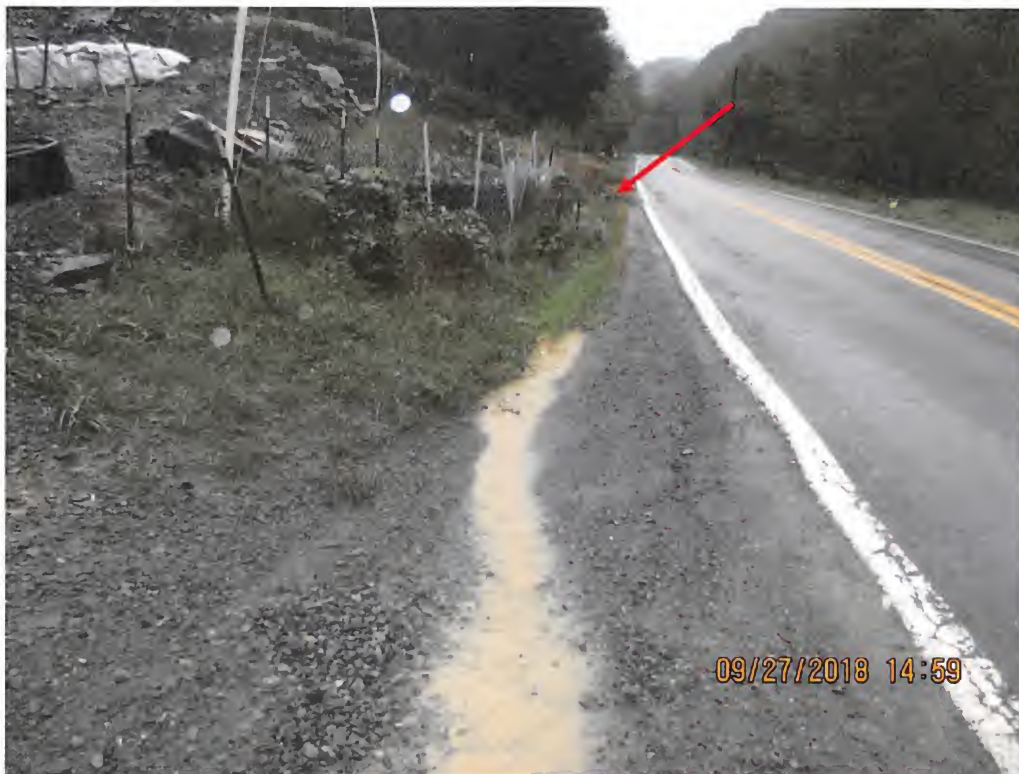
Sediment laden water accumulating and draining towards roadside ditch that intersects with S-A60 along Route 122.

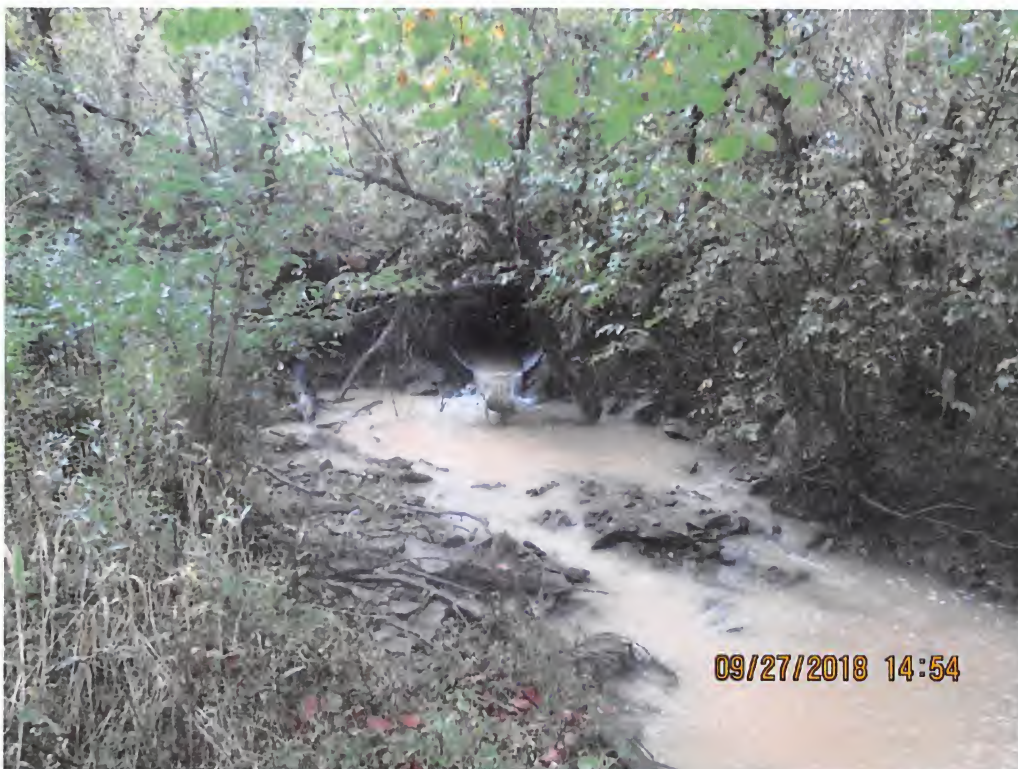
Sediment laden water leaving ROW intercepted by ditch flowing towards Stream (S-A60). Arrow depicts where ditch connects to stream S-A60 and flows under road via culvert.

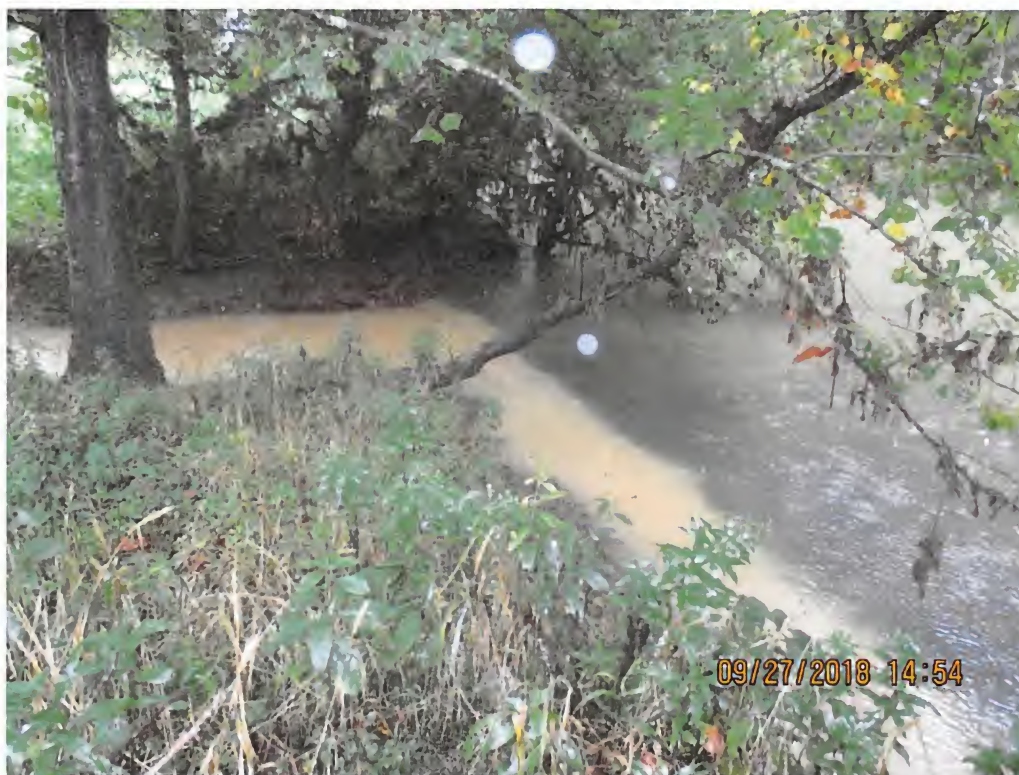
Location where sediment laden water was entering stream S-A60.

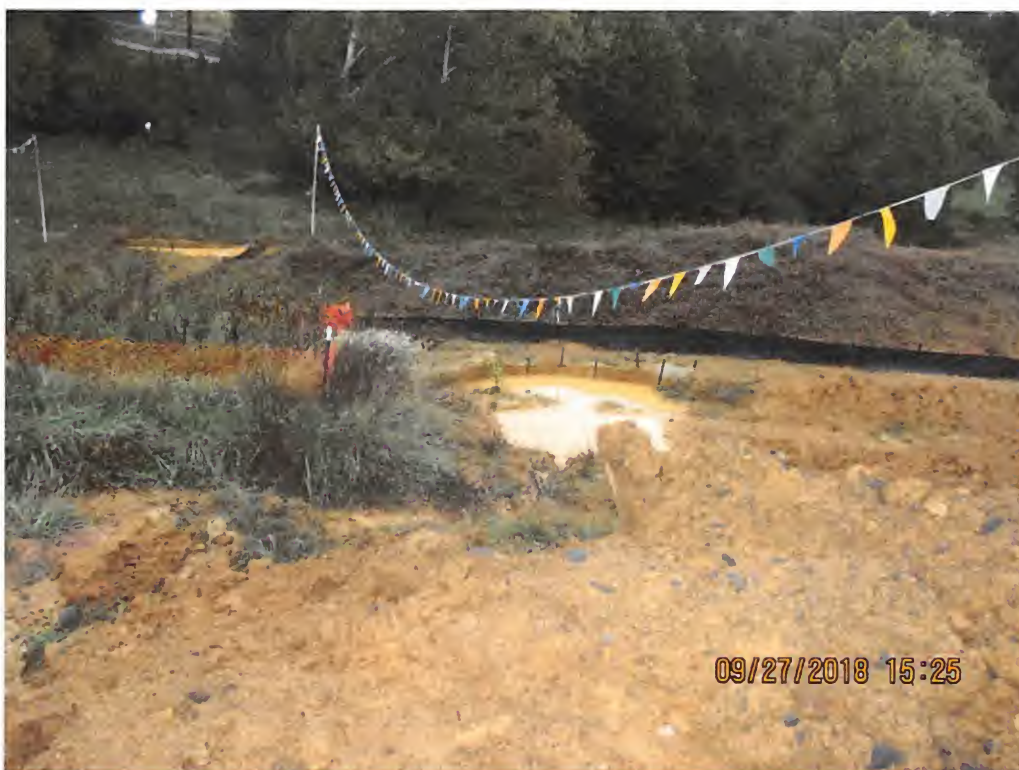
Overview of slope leading towards Stream (S-A60) near station number 9639+00.

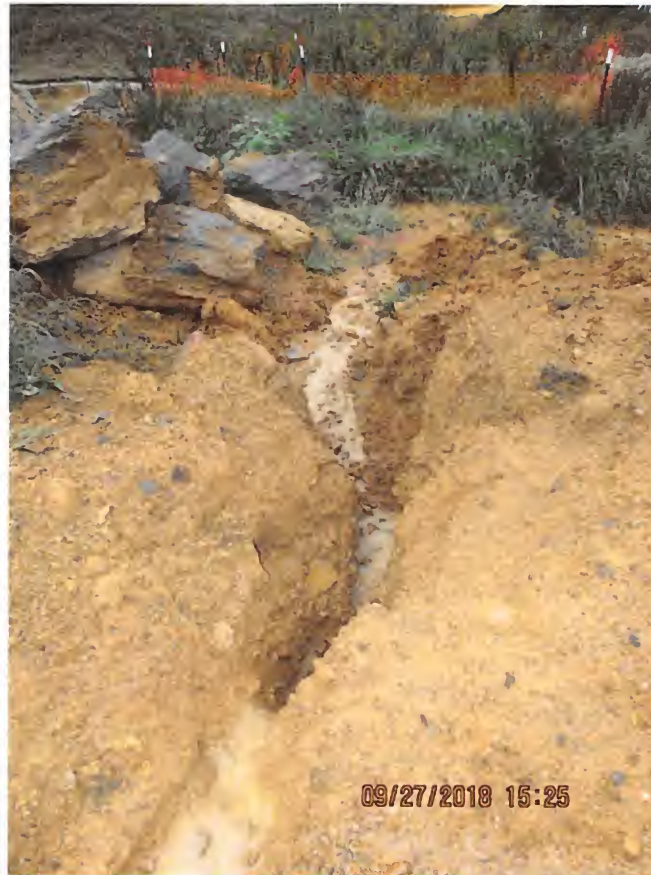
Water bar terminus leading to BMP. Erosion occurring due to channel not being stabilized.

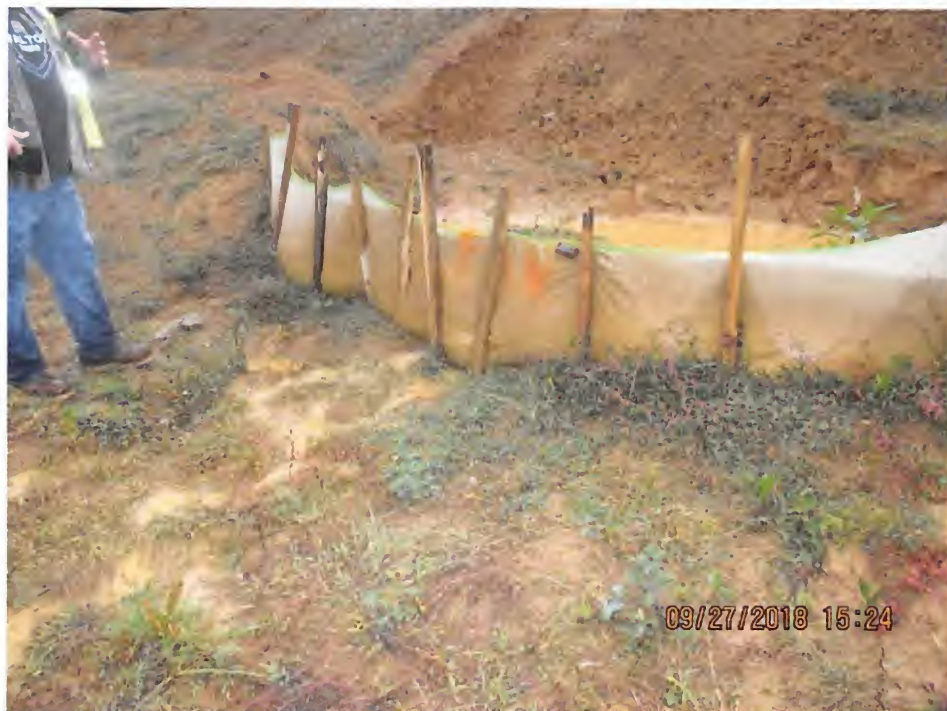
Sediment laden water passing through/under BMP.

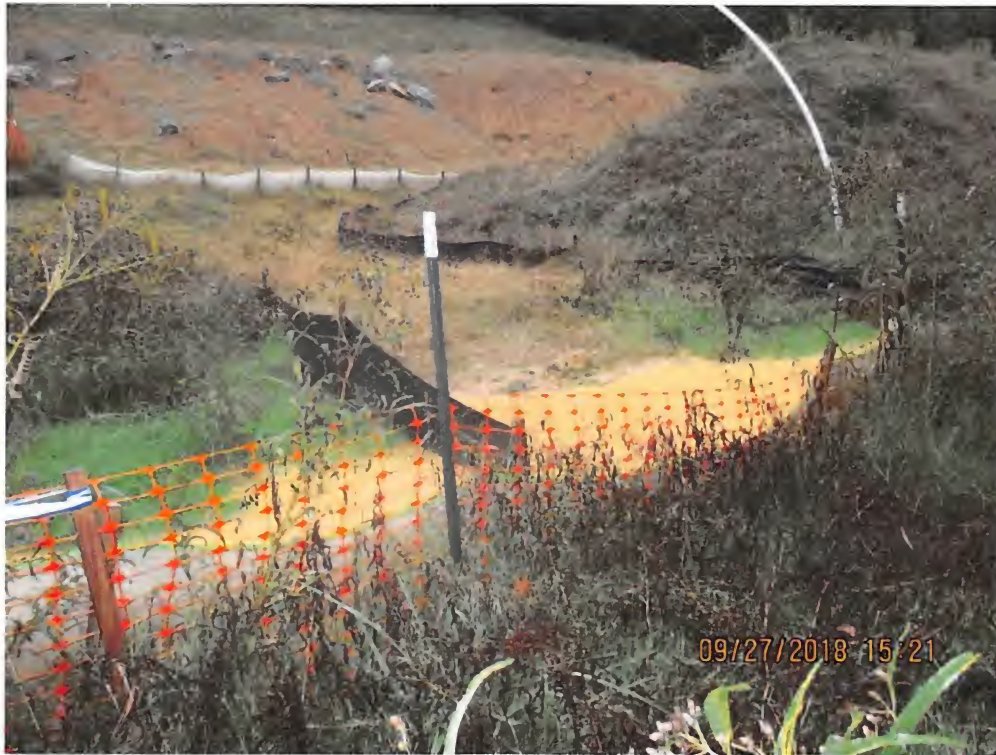
Lack of fill slope protection causing erosion and sediment laden water to accumulate and overwhelm BMP.

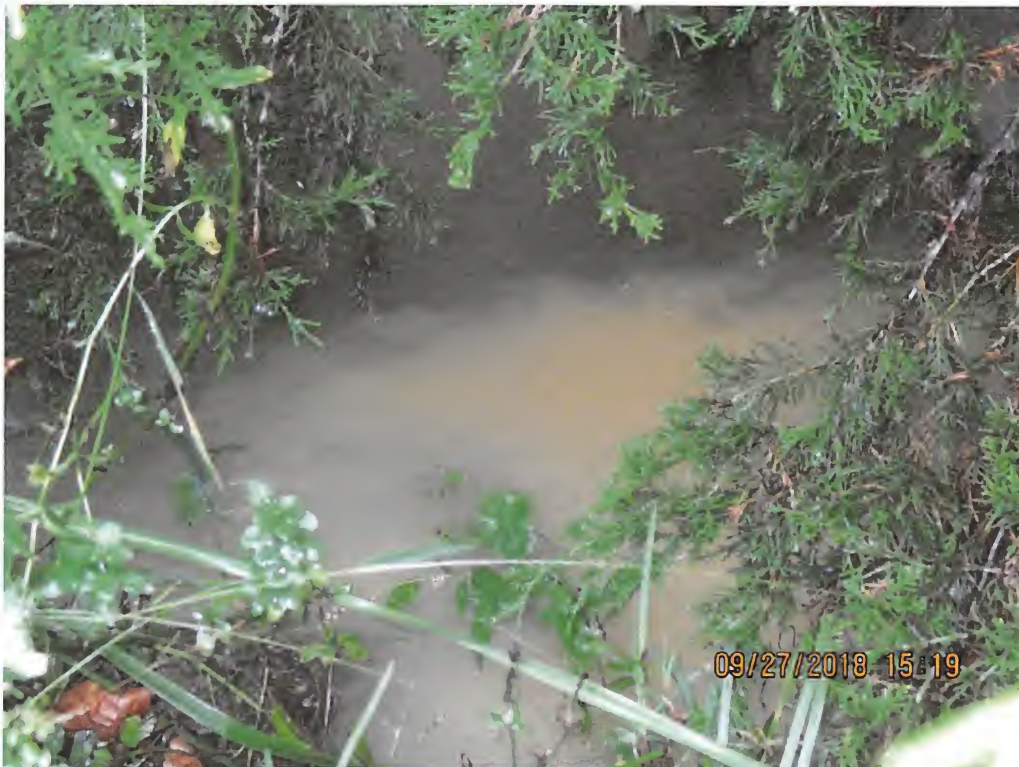
Sediment laden water leaving project and entering stream (S-A60).

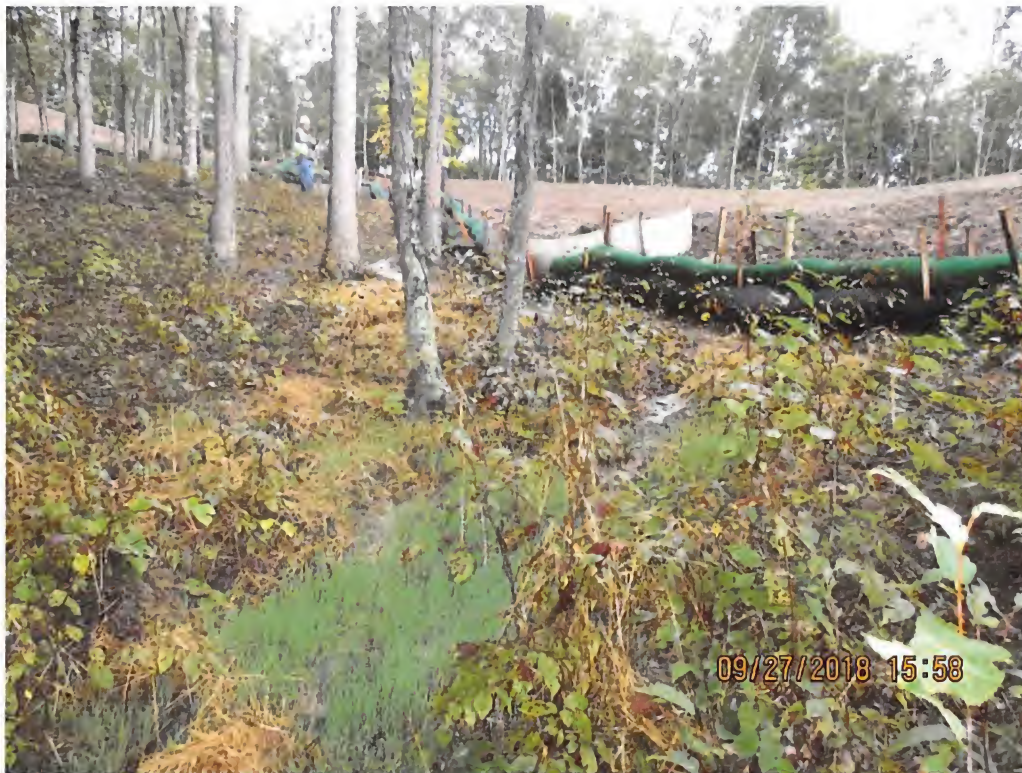
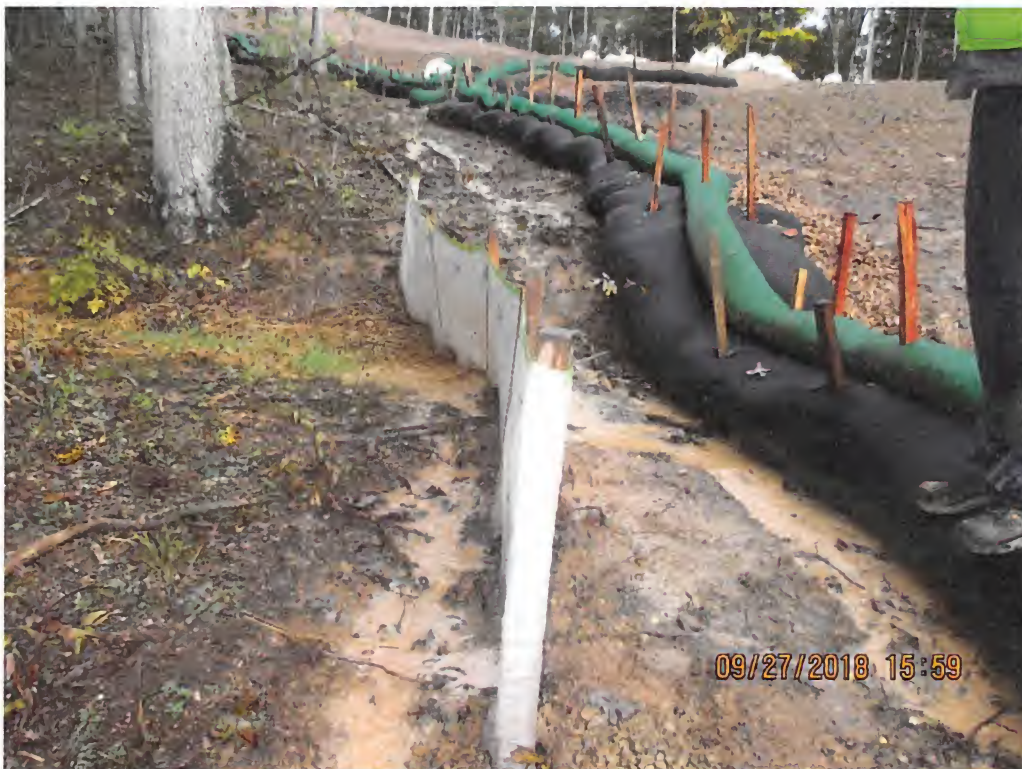
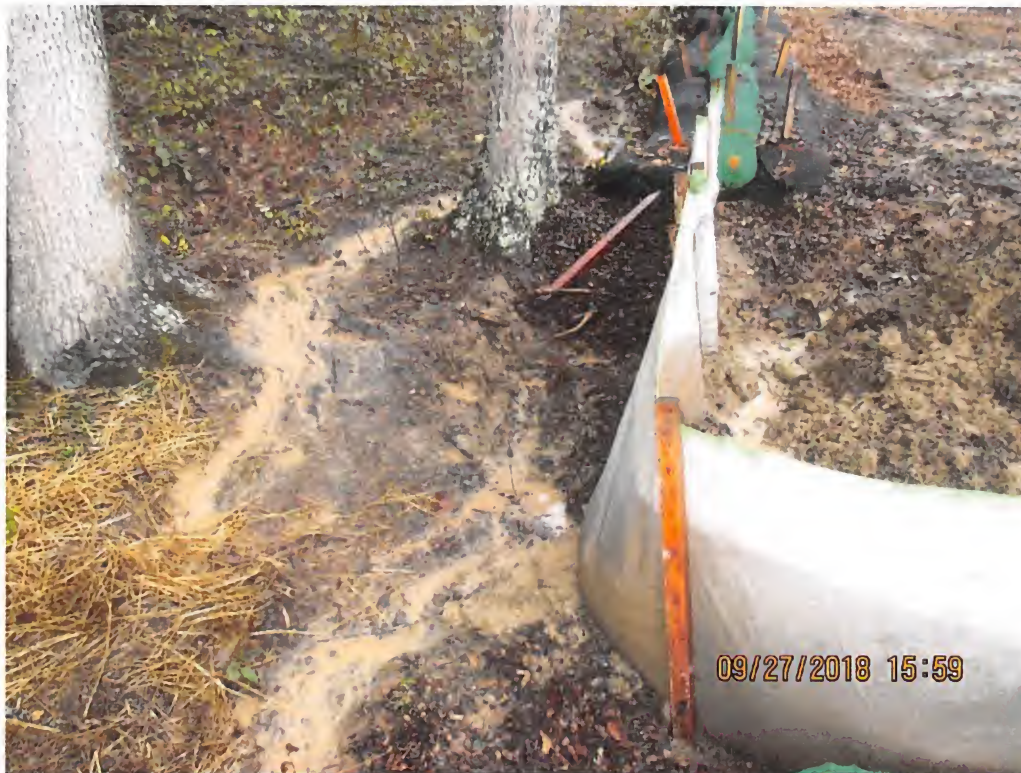
Areas near station number 9417+75 where water bar terminus being overwhelmed with sediment laden water.

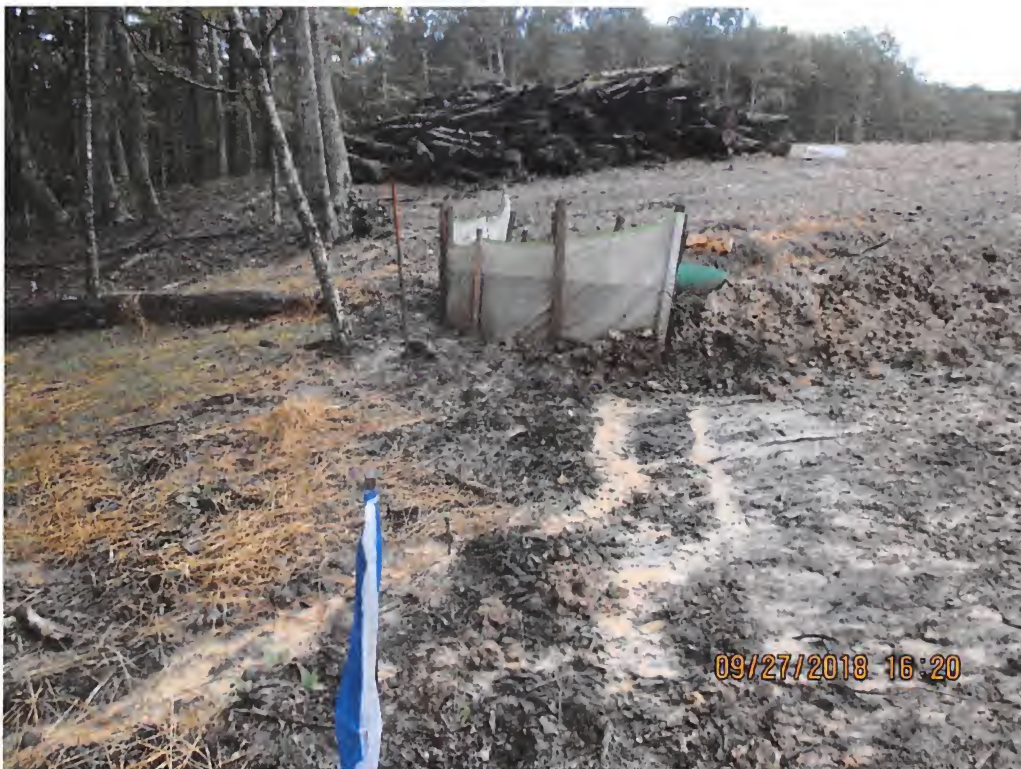
Sediment laden water flowing past BMP near Station #9417+75

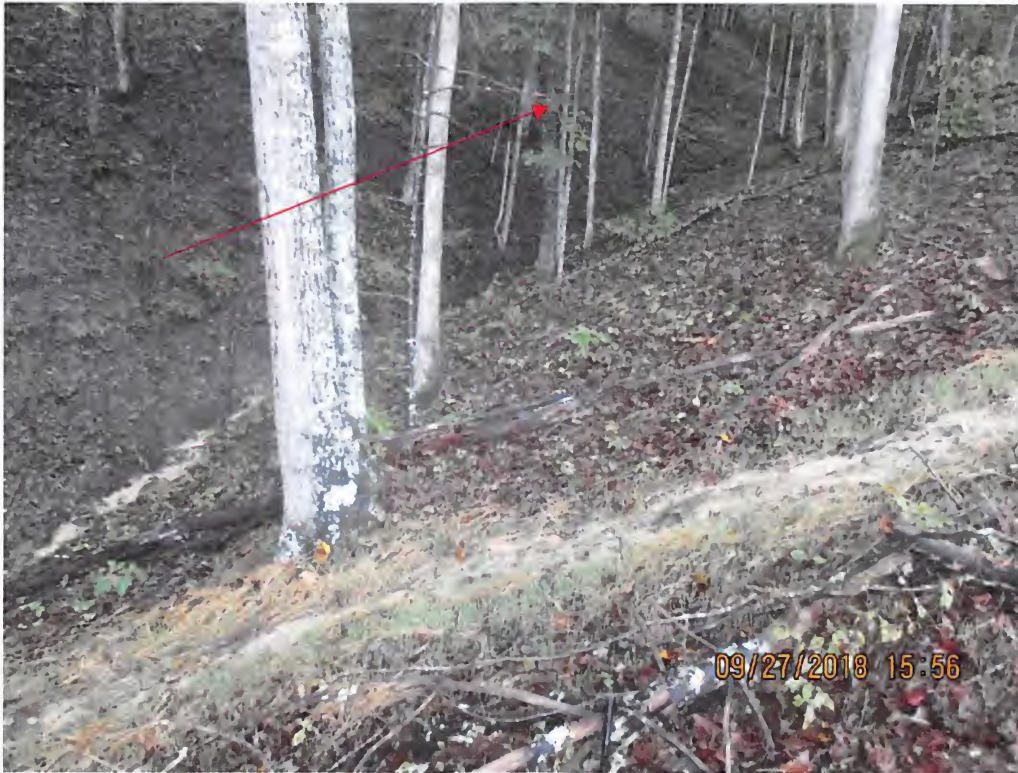
Sediment laden water being transported off ROW and past LOD into ephemeral streams near Station #9417+75. Red arrow depicts where ephemeral splits and goes upslope towards spring.

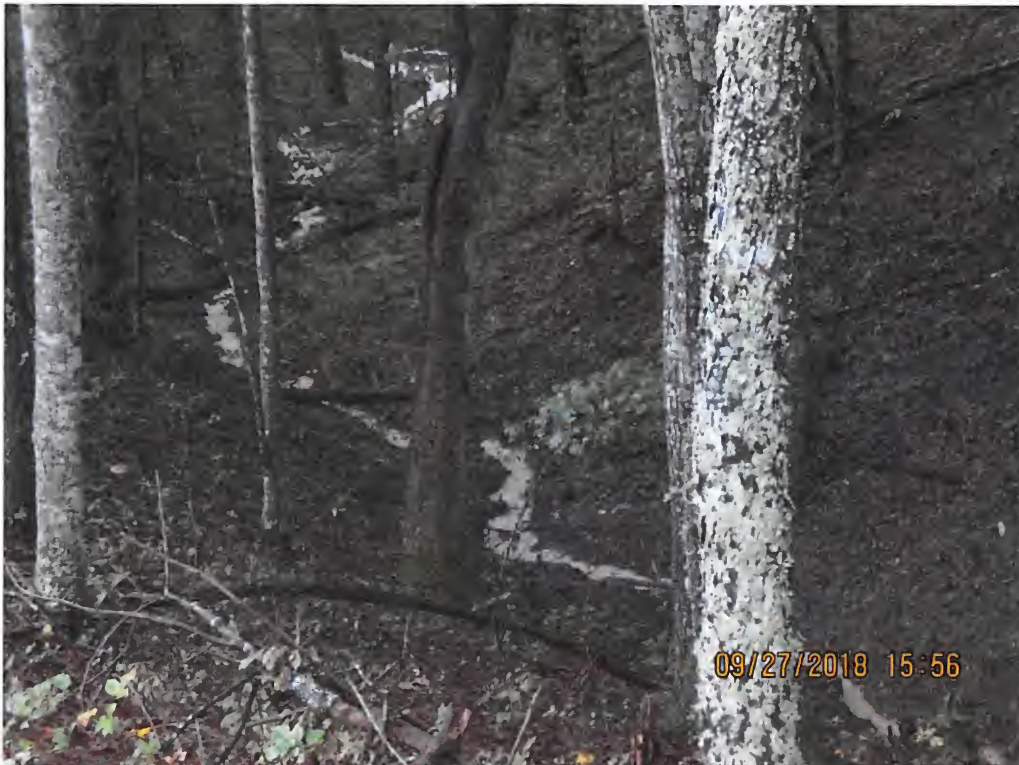
Main stem of ephemeral stream heading towards Stream S-A60 transporting sediment laden water into Indian Creek.

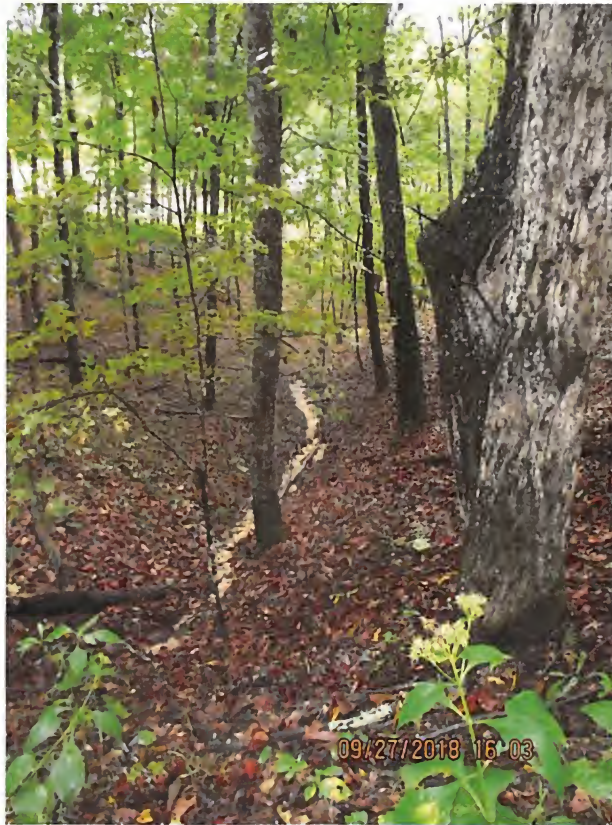
Standing on top of ridge looking down at spring seeping out of hillside transporting sediment laden water.

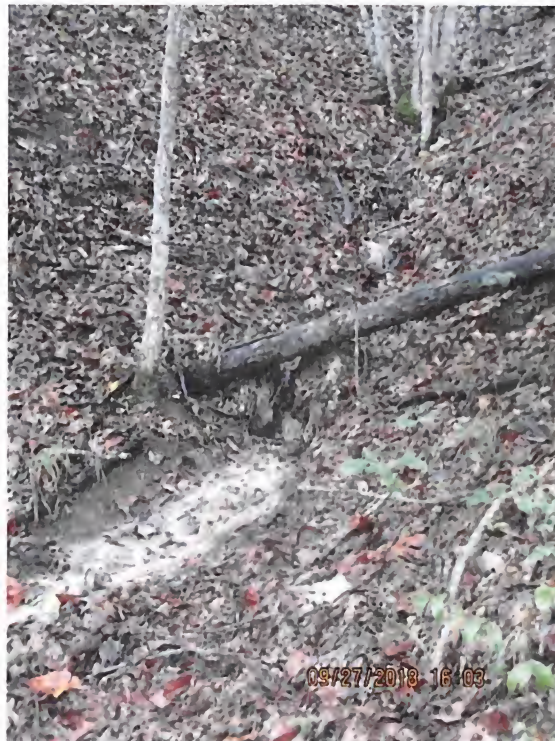
Spring/seep transporting sediment laden water.

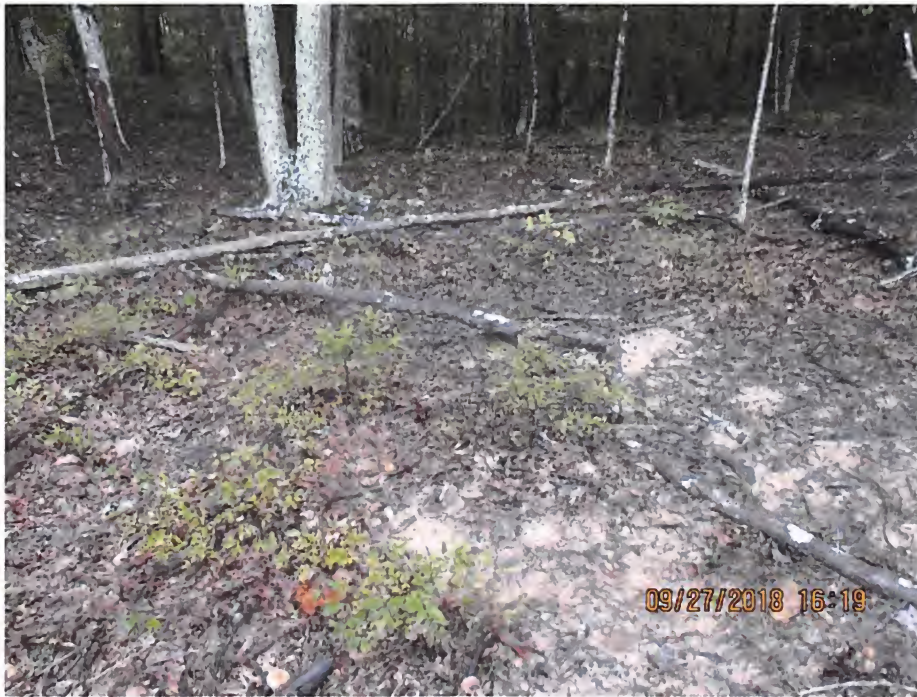
Area above spring/seep where off site sediment deposits were observed past LOD.

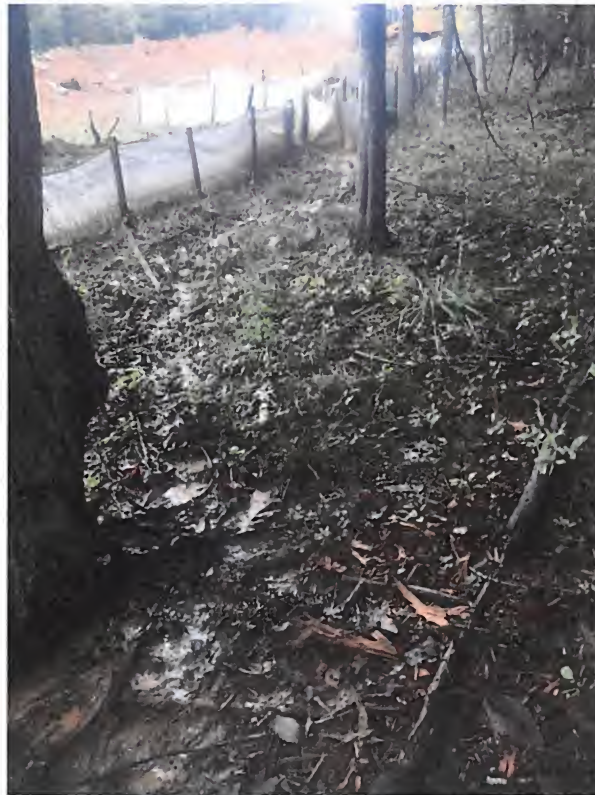
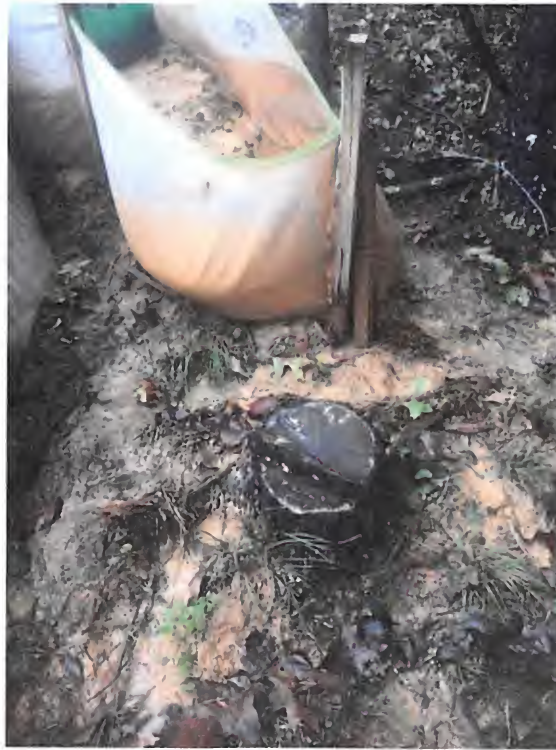
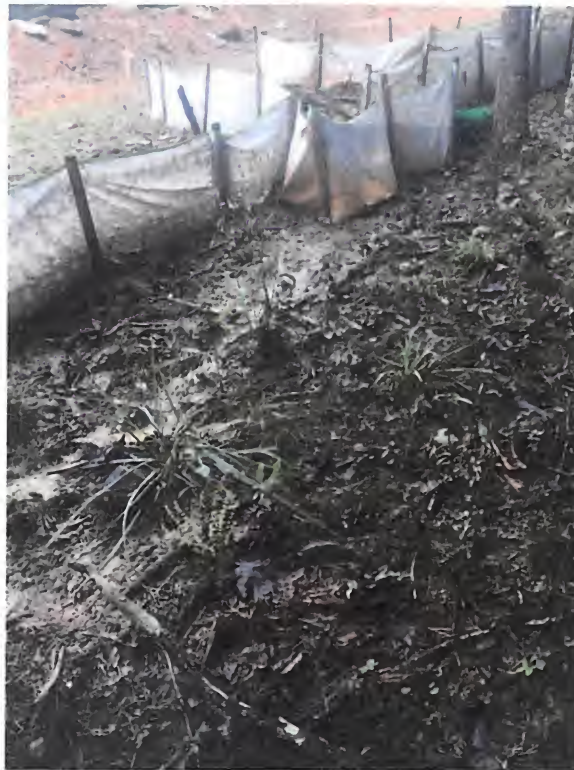
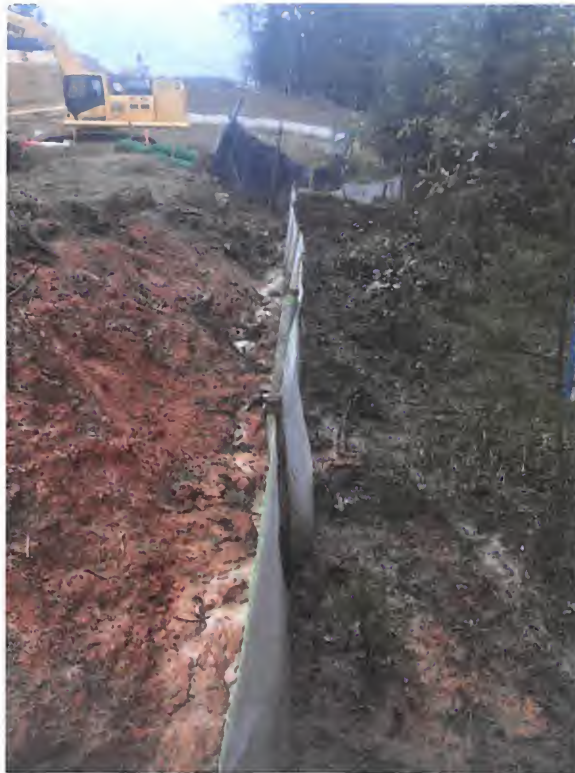
ROW near station numbers 9779+00 and 9778+00 where water bar outlets were being overwhelmed and sediment laden water was passing through and under and being transported past LOD.

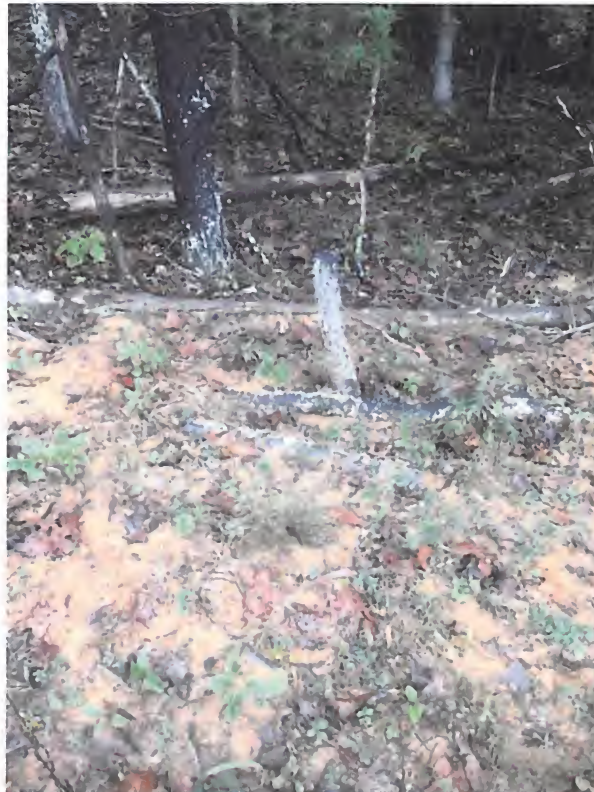
Off-site sediment deposits near station number 9779+00.

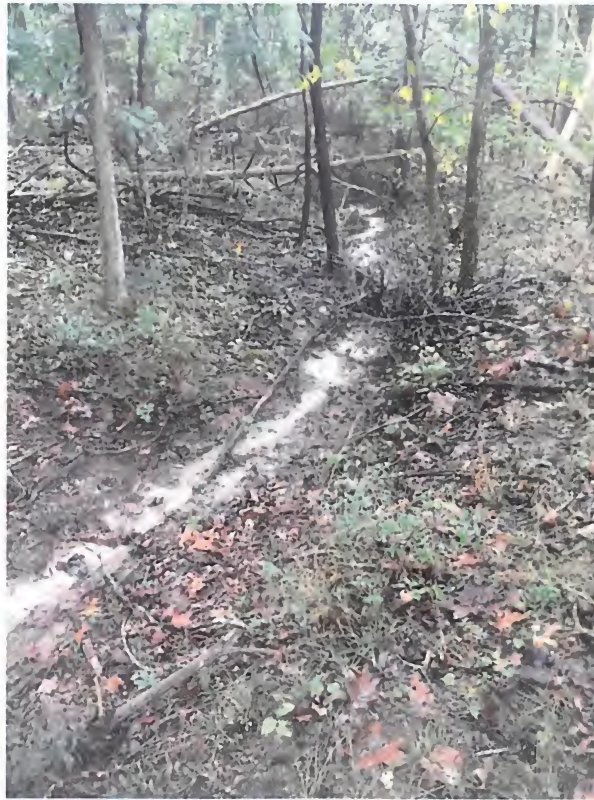
Ephemeral stream near Station #9778+00 being impacted by sediment laden water and flowing downhill and entering roadside ditch at Ellison ridge road.

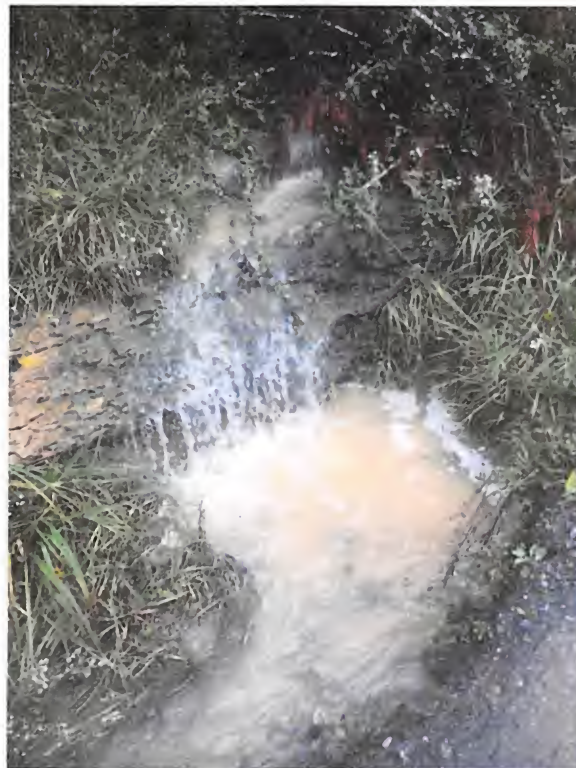
Ephemeral stream discharging into roadside ditch along Ellison Ridge Road.

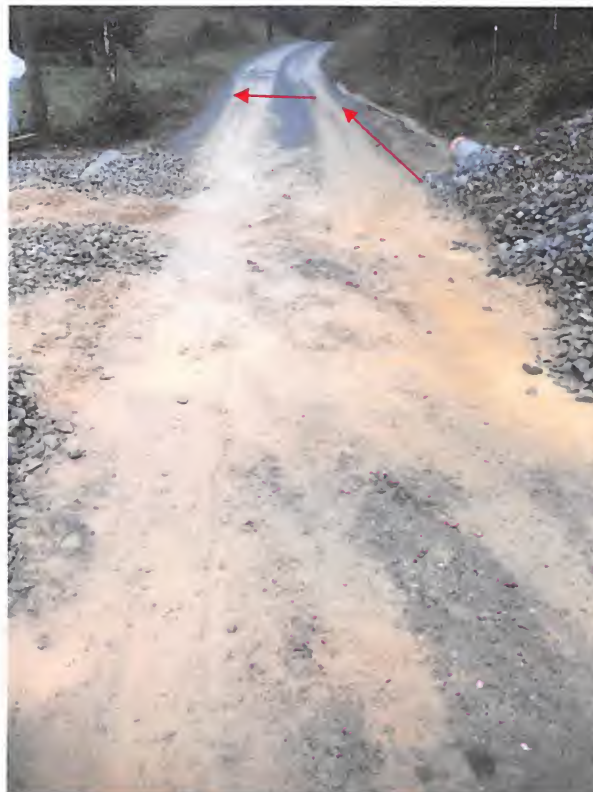
Sediment laden water flowing through culverted stream crossing and under road through culvert and into stream on other side of Ellison ridge road. Mud also present on road.

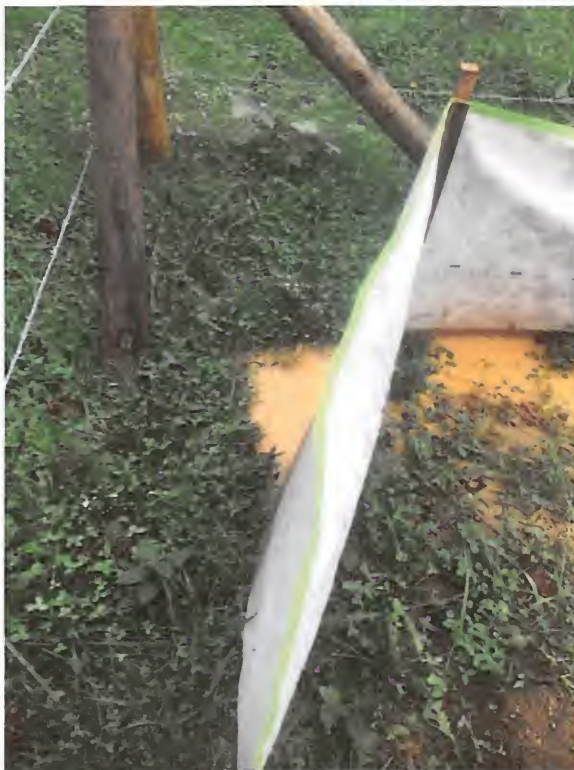
Sediment laden water flowing under and through BMP near station number 9784+00.

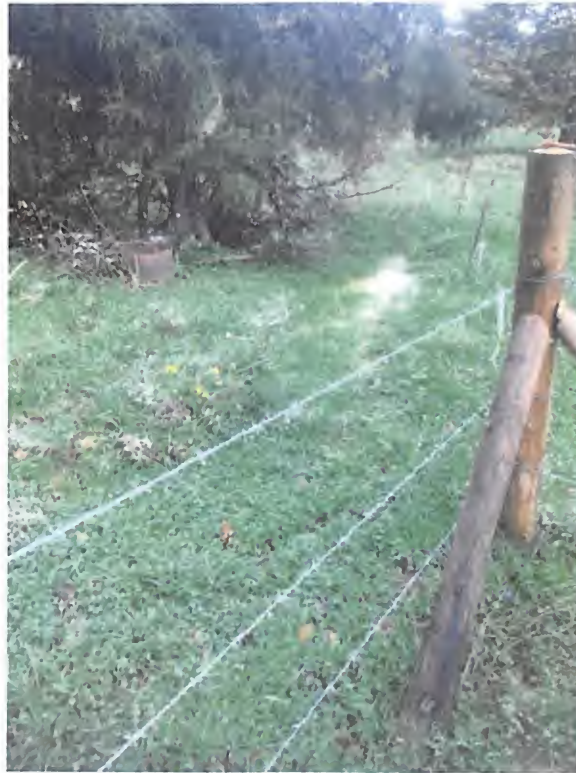
Sediment laden water infiltrating past LOD and seeping into wetland (W-22) and entering stream (S-Z3) near station number 9784+00.

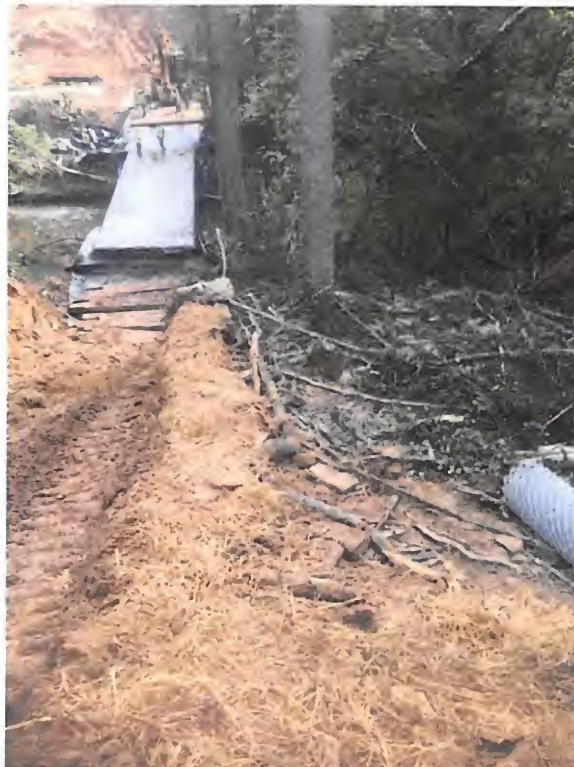
Facing Hans Creek near Station #9907+00. Super Silt fence located next to chain link had failed and sediment deposits were observed migrating towards Hans Creek.

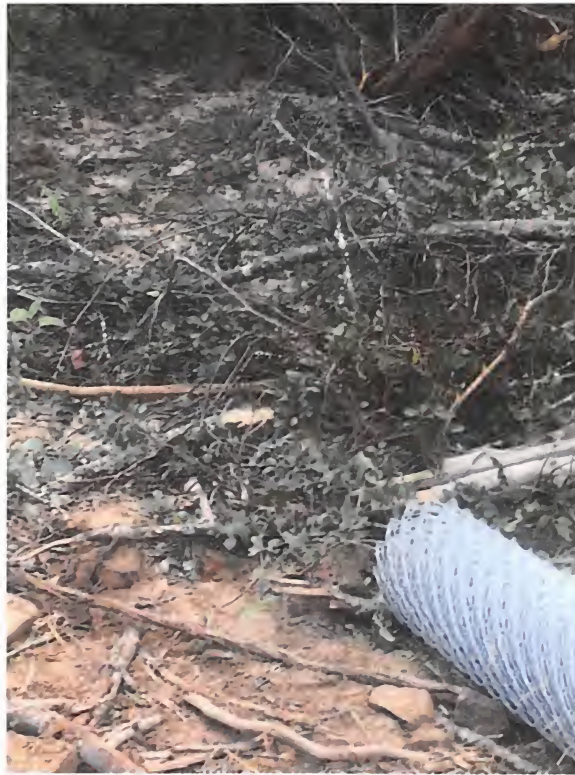
Close up of sediment that has been deposited past BMP.
